Preliminary Assessment of Building Damages in Hatay Region Based on the February 6, 2023, Earthquakes

¹Fazıl Abdukadir Çağlar, *¹Sedef Kocakaplan Sezgin, ² Ehsan Ahmadi, and ³Mohammad M. Kashani *¹ Faculty of Engineering, Department of Civil Engineering, Bursa Technical University, Türkiye ²Principal Engineer, Farrat, Manchester, England, UK ³Faculty of Engineering and Physical Sciences, University of Southampton, Southampton, UK

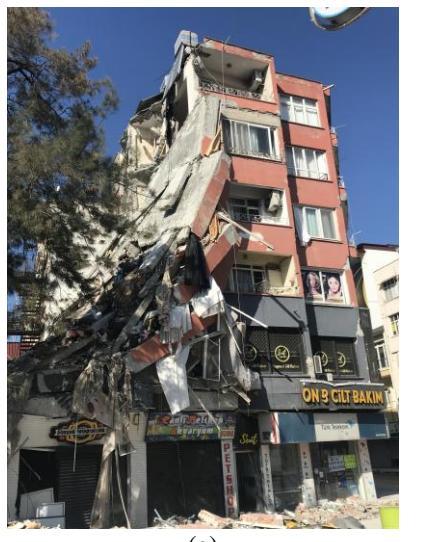
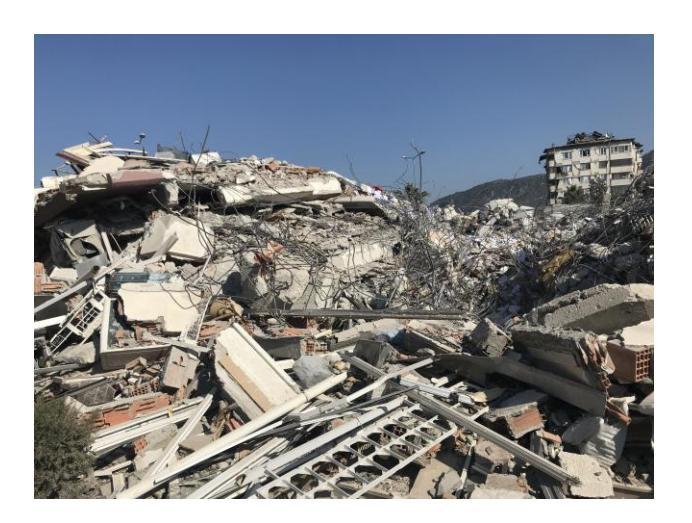
According to The Republic of Türkiye Ministry of Environment, Urbanization, and Climate Change [10], 10,991 buildings were heavily damaged and collapsed in Hatay. The primary causes of the observed damage and failures in reinforced concrete (RC) buildings were attributed to the quality of construction materials, improper reinforcement placement, corrosion of reinforcing bars, as well as poor design and implementation practices. In several buildings, it was observed that columns and shear walls were arranged only in one direction, limiting the structure's earthquake resistance in the perpendicular direction. However, the presence of shear walls in some buildings helped to prevent failure or damage in other load-bearing elements.

Due to the limited space, only specific damages are included in this paper. Figure 5 illustrates the example of heavily damaged totally collapsed buildings in Iskenderun and Antakya. The use of plain reinforcement can be seen in Figure 5b.

(a) (b) **Figure 5.** Heavy damage and collapsed RC buildings in (a) Iskenderun, and (b) Antakya.

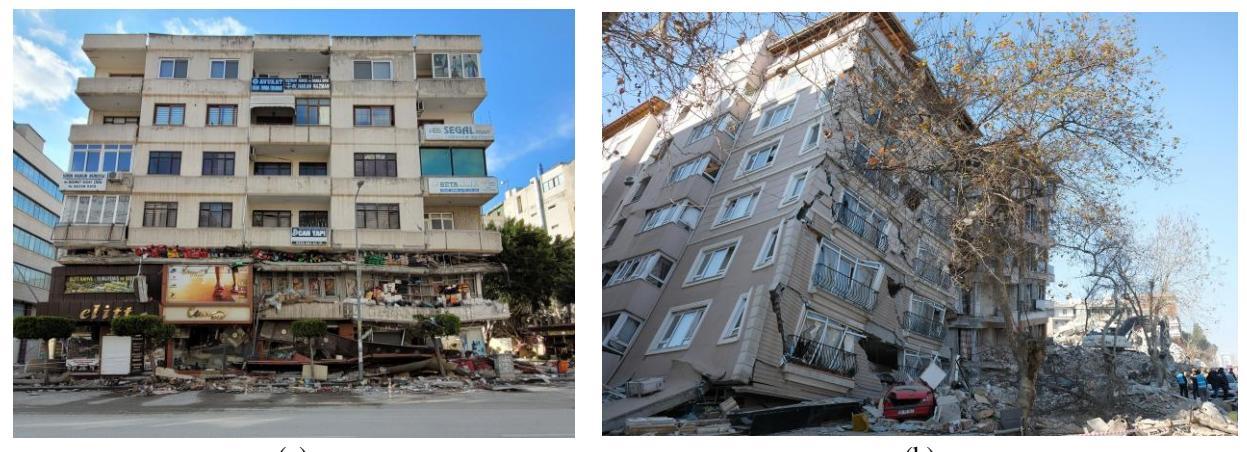
(a) (b) **Figure 6.** Damage due to soft story (a) Iskenderun, and (b) Antakya

Another frequently observed type of damage in the region is the failure caused by the presence of soft stories referred to as system level damage. Figure 6 provides two examples of such failures. The use of glass windows instead of infill walls on the street-facing façade of commercial shops, combined with the increased floor height at this level compared to others, increases deformation demands, which ultimately contributes to the damage in these buildings.

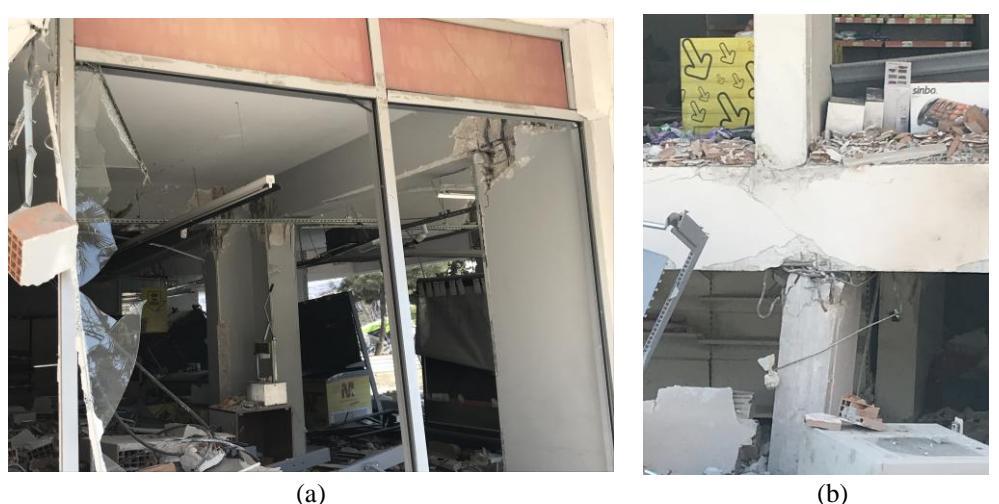
The beam-column joints in the earthquake-affected region were found to be highly susceptible to damage. Seismic codes for ductile design impose strict guidelines for the design and detailing of these confinement zones. However, in many buildings in the Hatay region, column overlap joints were improperly placed within the beam or floor, making it easier for columns to pull out from the joints as seen in Figure 7.

(a) (b) **Figure 7.** Damage observed in beam-column joints in Antakya.
